## V2 was driving southbound on HWY 305 approaching the intersection with Hidden Cove RD. D2

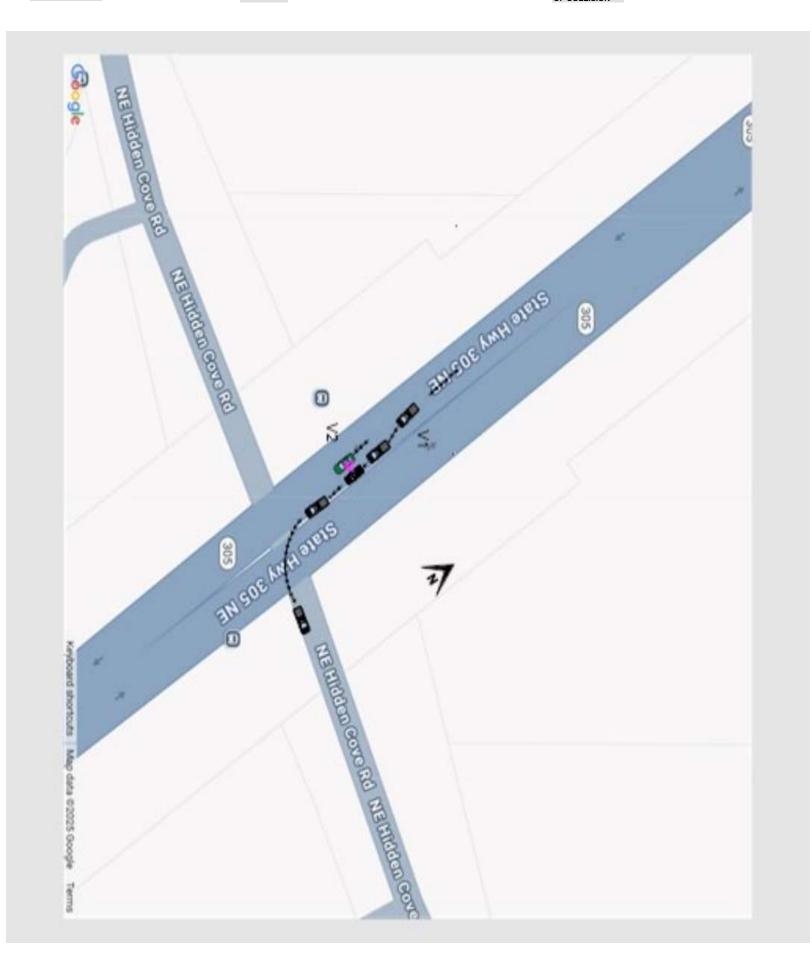
I inspected the damage on V2. V2 sustained light dentes and scrapes to the side and front panels of the vehicle, as well as scrapes to the front driver's side wheel. Most of the damage appears to be from the tires of V1 rubbing against V2.
