## NARRATIVE

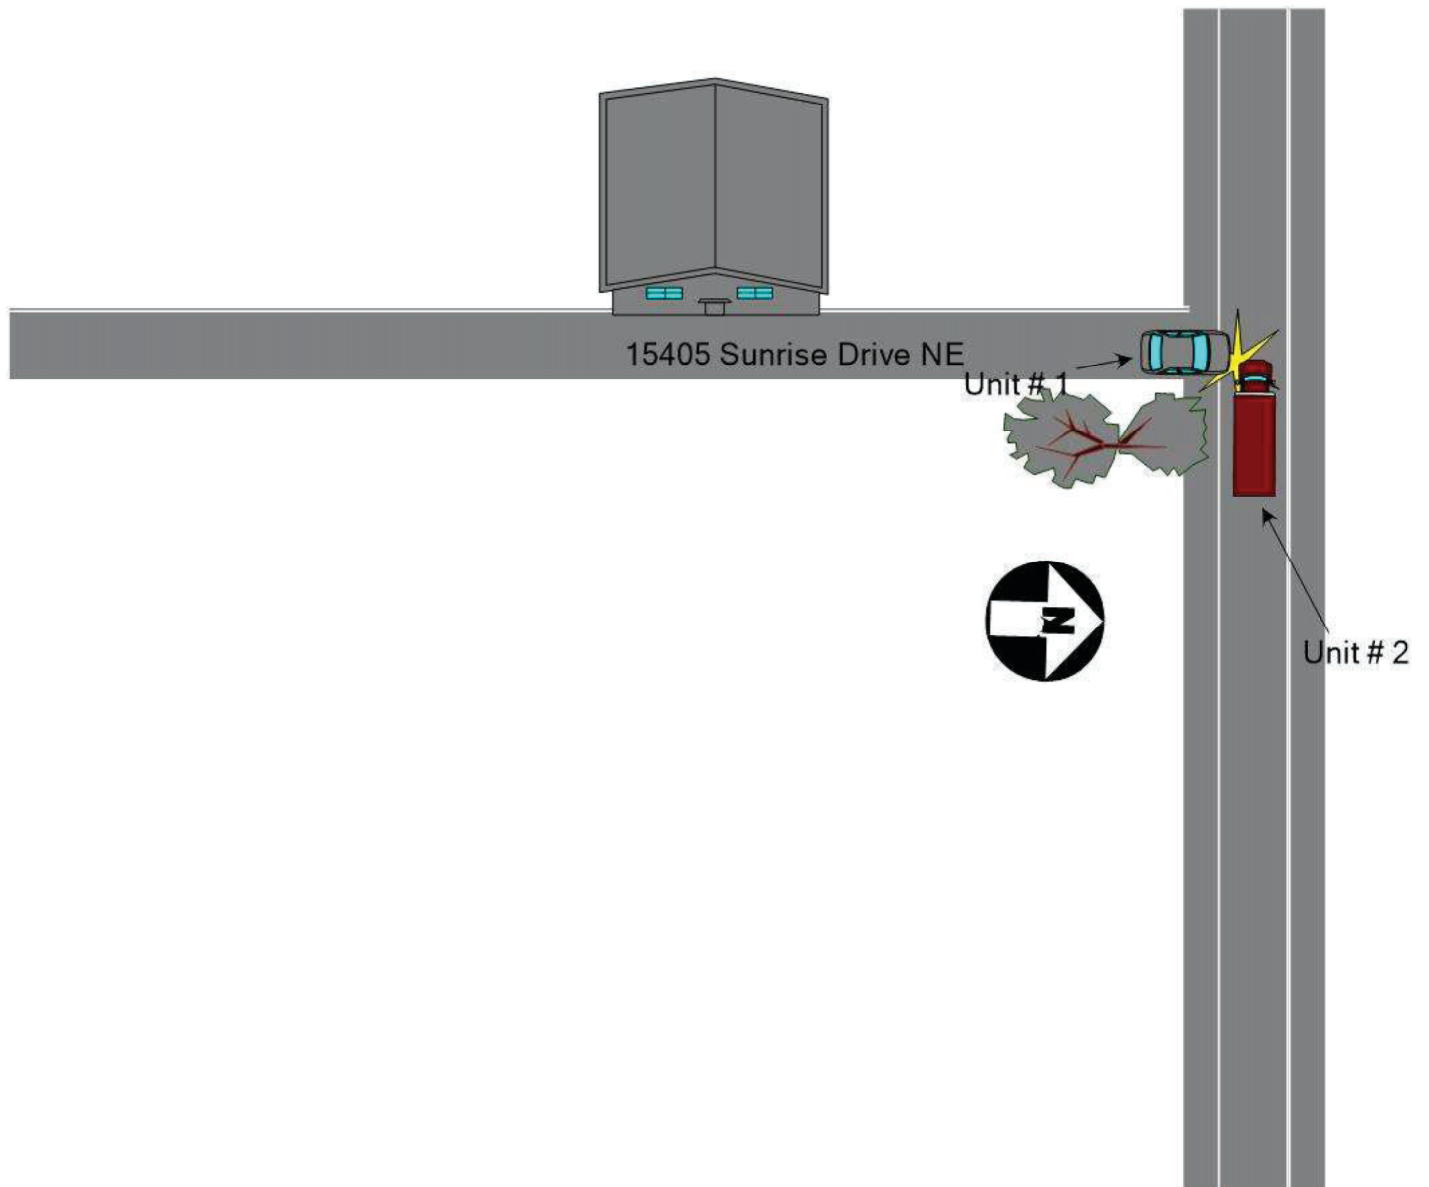
Driver of #1 pulled out from her private residence into the path of an oncoming roofing van (unit #2) that was traveling west on a paved but private portion of Sunrise Drive. Unit #1 had condensation present on the windows and driver's field of view was obstructed by a large hedge. Driver of Unit #2 advised that driver of Unit #1 was driving "too fast." Driver of Unit #1 was not present when officer arrived, but her mother (RO of the vehicle) was.
