NARRATIVE

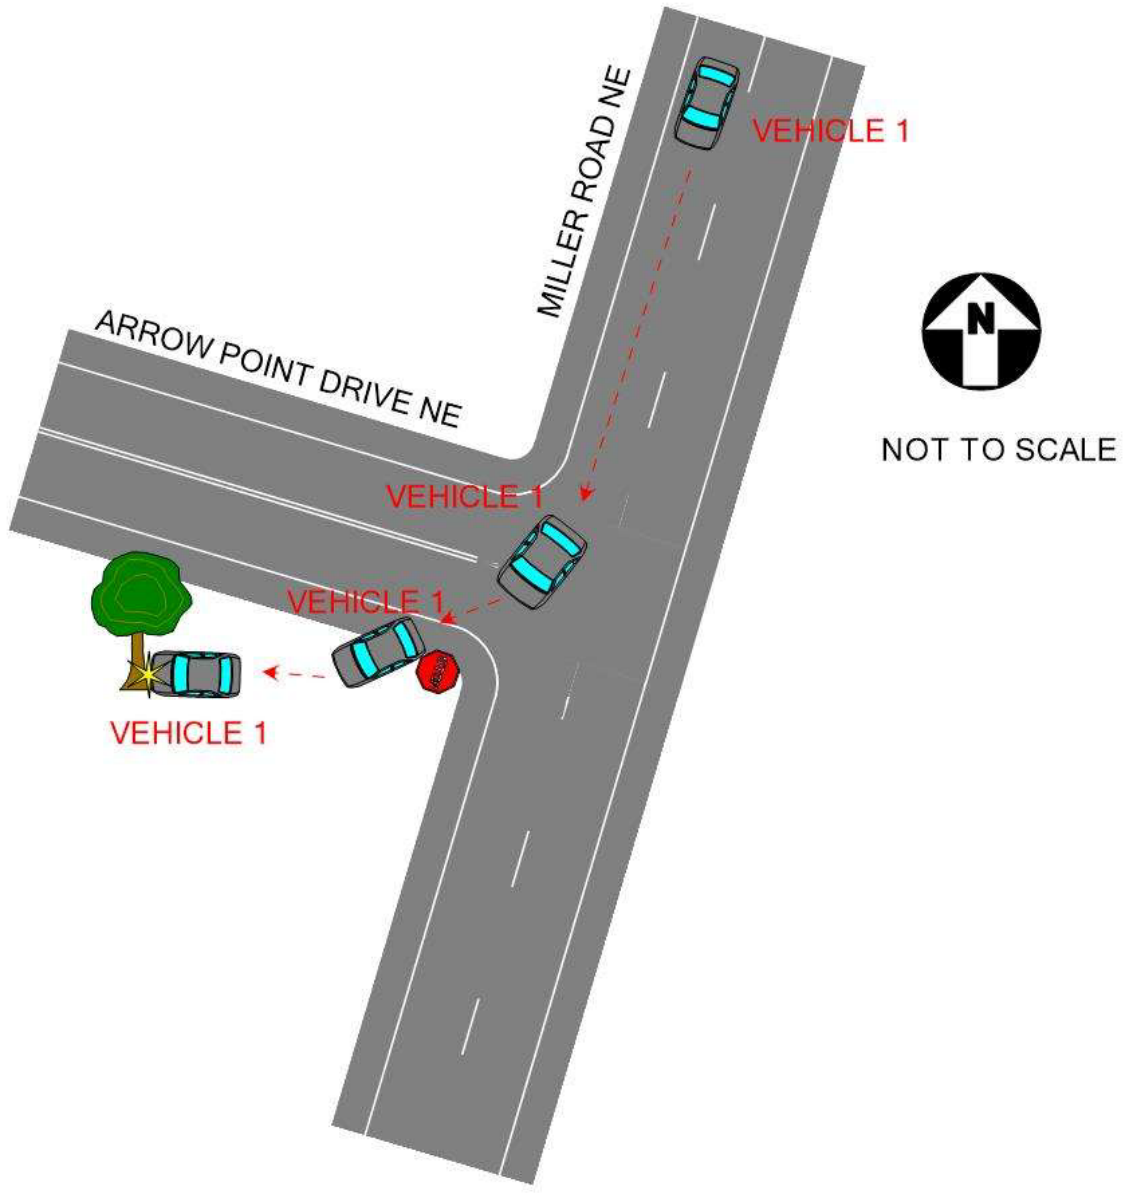
Vehicle 1 was speeding while traveling south on a straightaway portion of Miller Road. Vehicle 1 attempted to turn at the intersection of Miller Road and Arrow Point Drive NE while driving too fast in wet road conditions. As a result, Vehicle 1 went off the roadway past the stop sign at the intersection into the trees. Vehicle 1 collided with a tree south of the Arrow Point Drive NE road edge, which caused damage to the front end and underside of the vehicle.
