On 06/28/2022 at approximately 0123hrs, CENCOM advised of a heard only collision in the area of SR305 and Sportsman Club Rd.

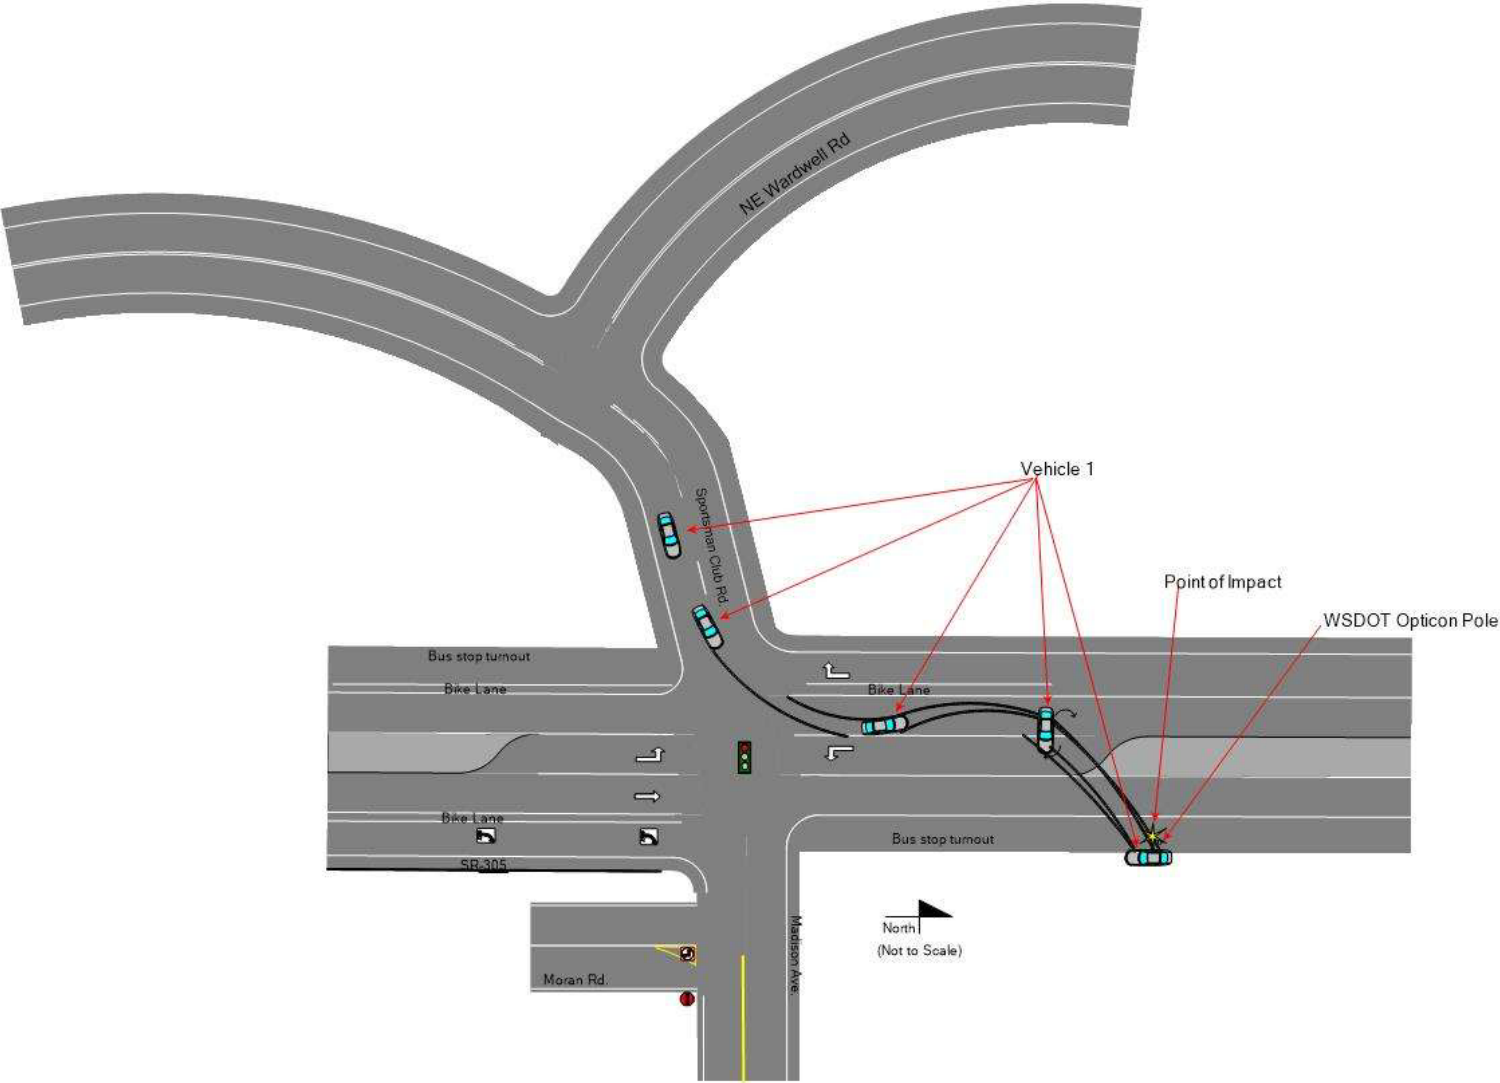
Upon looking at the location and orientation of the vehicle and walking the skid marks all the way back to where they began on Sportsman Club Rd, I was able to determine how Vehicle 1 traveled along the roadway. Vehicle 1 was driving East on Sportsman Club Rd, crossed the centerline with the left side of the vehicle and entered the intersection at a speed fast enough to lose traction and create skid marks over the pavement.

As the vehicle made the left turn from Sportsman Club Rd, it turned into oncoming traffic, and it appeared to have accelerated. The acceleration caused the back of the vehicle to fish tail all the while still traveling north in the south bound lane. Vehicle 1 lost control and spun almost 180 degrees where it struck a WS DOT optacon pole with the left rear corner of Vehicle 1. The pole was sheered off at the base and was laying underneath the vehicle.

If Vehicle 1 had come from a complete stop and began accelerating from the stop light. Driver 1 should have had plenty of time to see a deer in the roadway and Vehicle 1 would have been in the correct lane of travel and could have easily stopped before striking a deer in the roadway. Furthermore, the skid marks on the roadway show the vehicle never swerved it only lost control due to a rear wheel drive vehicle attempting to accelerate to quickly while not driving in a straight line.
