NARRATIVE

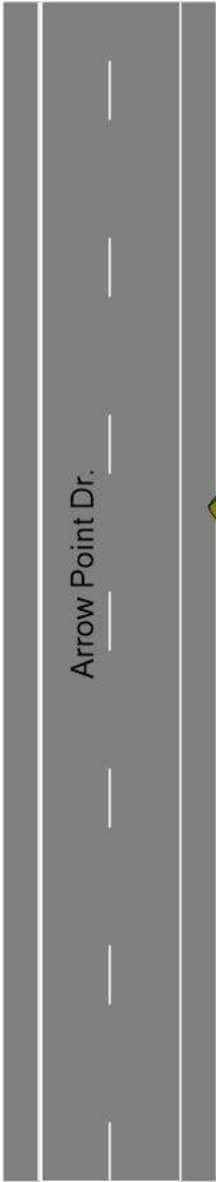
Vehicle #1

Driver of vehicle # 1 was originally west bound on Arrow Point Dr. and drifted off the right paved portion of the road. As he was backing onto the roadway he backed across the roadway and into a drainage ditch impacting a tree. The impact damaged the rear lift gate and shattered the rear window. Per the driver and the complainant the interior windows were fogged up limiting the vision of the driver. The driver of the vehicle was given the case number to this incident and directed to contact his insurance company.
