NARRATIVE

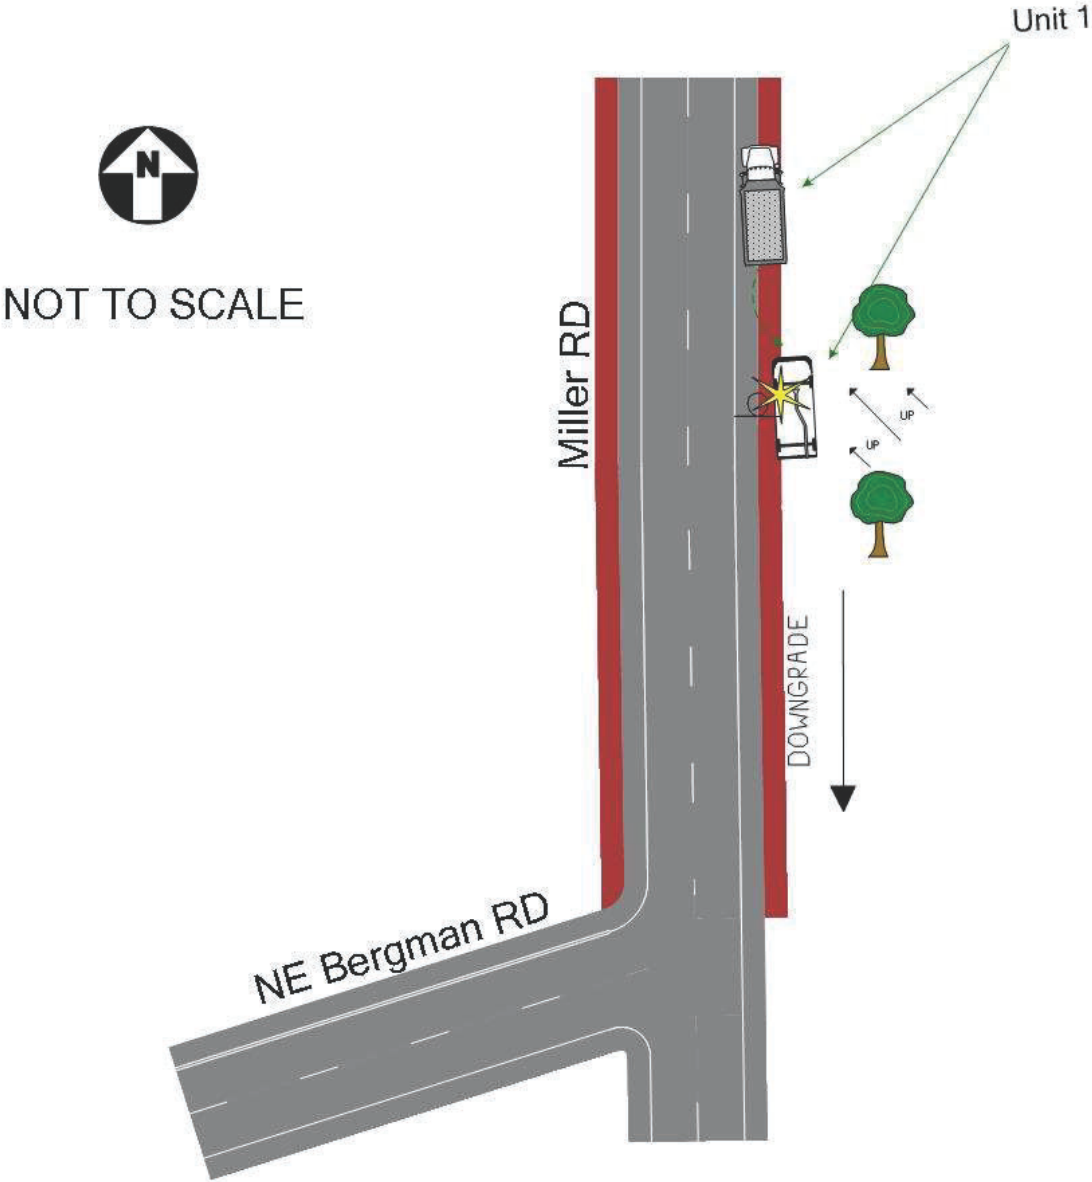
Unit 1 was parked on the dirt shoulder of Miller Road northbound approximately 150 feet north of Bergman Road. Unit 1 was attempting to back up southbound using the shoulder on Miller to have enough space to turn into the roadway. The shoulder of Miller was soft and muddy and Unit 1 rolled over on its side down an embankment.
