NARRATIVE

On April 20, 2023, at approximately 2145 hours, CenCom broadcasted an injury accident in the area of Fletcher Bay Rd. and Lynwood Center Rd. The vehicle had ended up at the bottom of an embankment. When officers came to the area, they saw that BIFD was on scene. Prior to the officer's arrival, dispatch had advised that one of the occupants had exited the vehicle and as they approached they saw both occupants out of the car and leaning against the it. The occupants identified themselves. As the officer was speaking to the driver, they could smell the odor of an intoxicant. The occupants were asked to stay put. Officers discussed that one officer would take the DUI investigation and the other would handle the accident investigation. (The driver was later charged with DUI.)

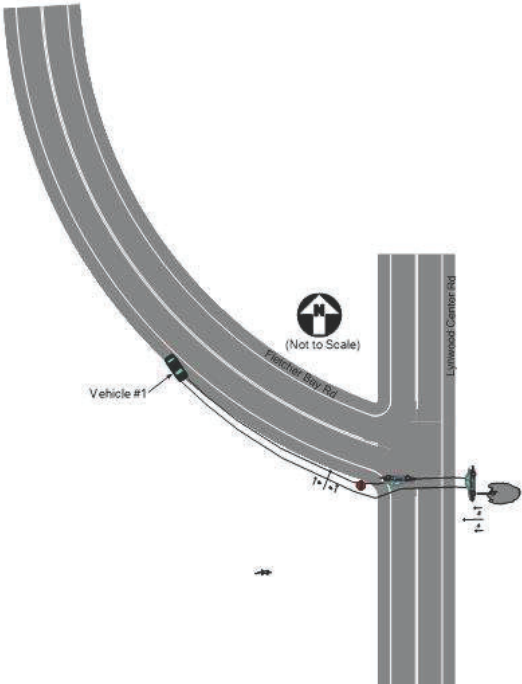
Once the car was pulled back onto the road, officer observed that the passenger side had noticeable areas on the front door, front passenger wheel and smaller areas where the metal was ground down from sliding on the asphalt. There were also two window – front door and rear – that had been broken out.
