## **NARRATIVE**

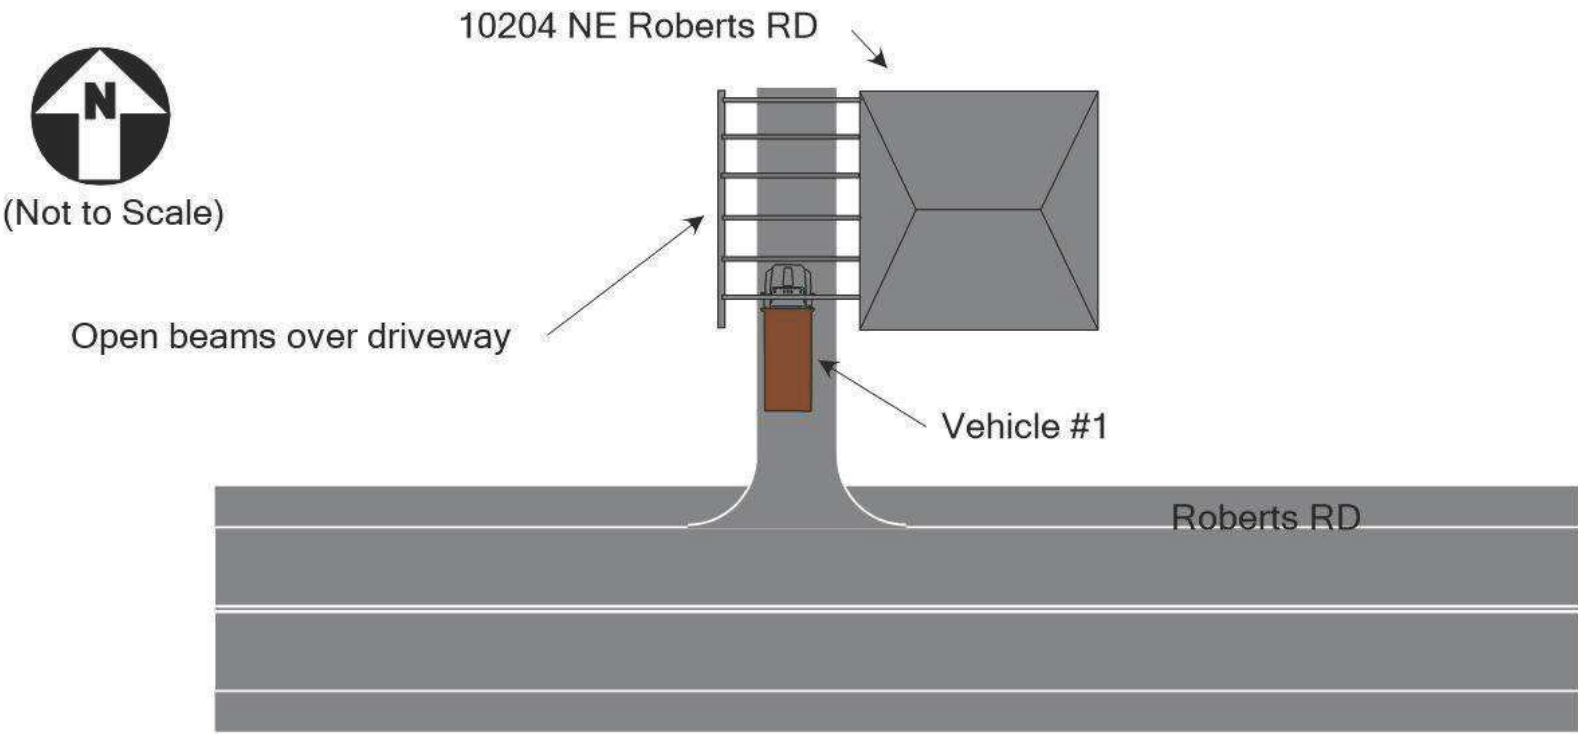
The driver had knocked the beam loose and dislodged the mounting hardware and pulled the beam 6' to the rear when backing up. The beam did not detach from the house, only the outlying support structure.
