NARRATIVE

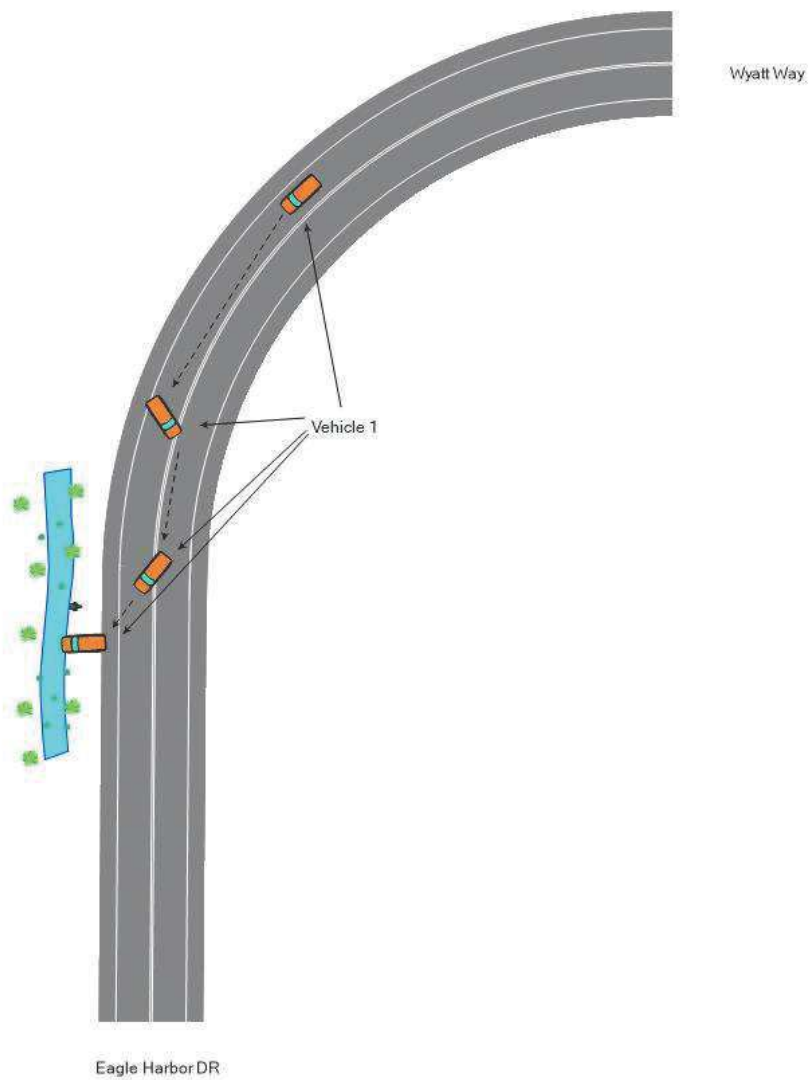
Vehicle 1 was traveling west on Wyatt Way approaching the left turn where Wyatt turns into Eagle Harbor DR. Vehicle 1 lost traction while rounding the corner, and slid off the roadway on the west shoulder. The front end of vehicle 1 nosed down into a culvert and Vehicle 1 was unable to remove itself.

Vehicle 1 had minor damage to the front end.

The driver stated that they estimated their speed to be fifteen miles per hour over the limit, and that they were going too fast to make the corner.
