NARRATIVE

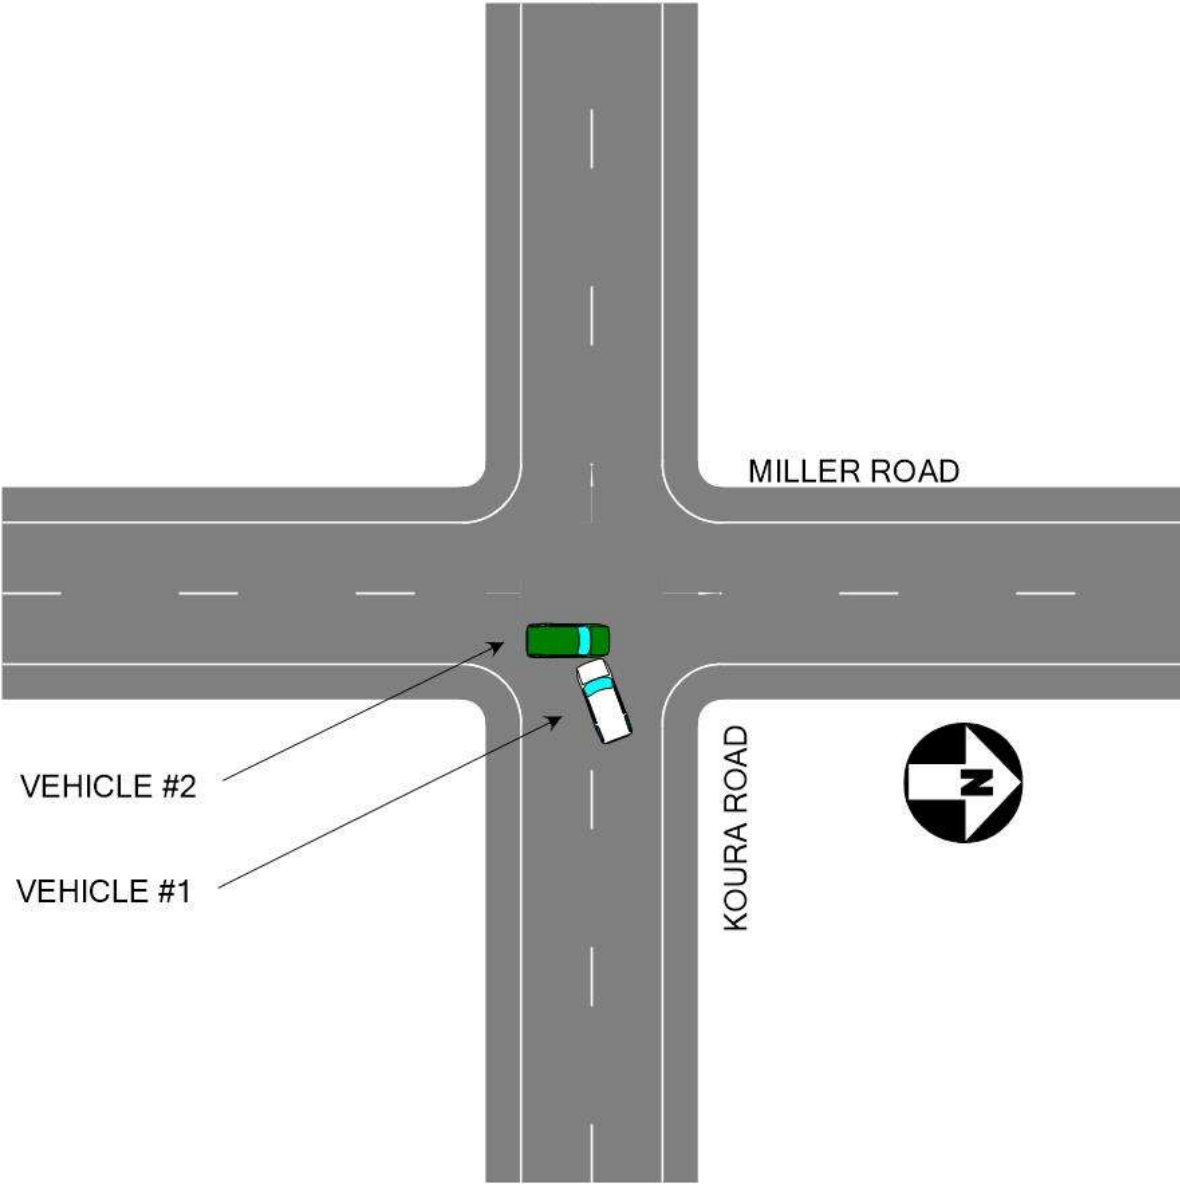
Driver #1 was westbound and stopped at the intersection of Koura Rd. and Miller Rd. Driver #1 was preparing to make a left turn onto southbound Miller Rd. Driver #1 saw a vehicle -Driver #2 - northbound on Miller Rd. Driver #2 signaled a right turn onto eastbound Koura Rd. Driver #2 told me that she had been mistaken as to which road she needed to turn on, deactivated her signal, and continued north on Miller Rd. Driver #1 provided the same basic fact set, adding that he began his turn and realized that Driver #2 was not going to turn. The point of impact on vehicle #2 was on the passenger side just aft of the front tire. The impact buckled the sheet metal of the front fender. The damage to vehicle #1 consisted of scrape and abrasion marks. Both drivers were given an exchange forms and referred to their respective insurers.
