NARRATIVE

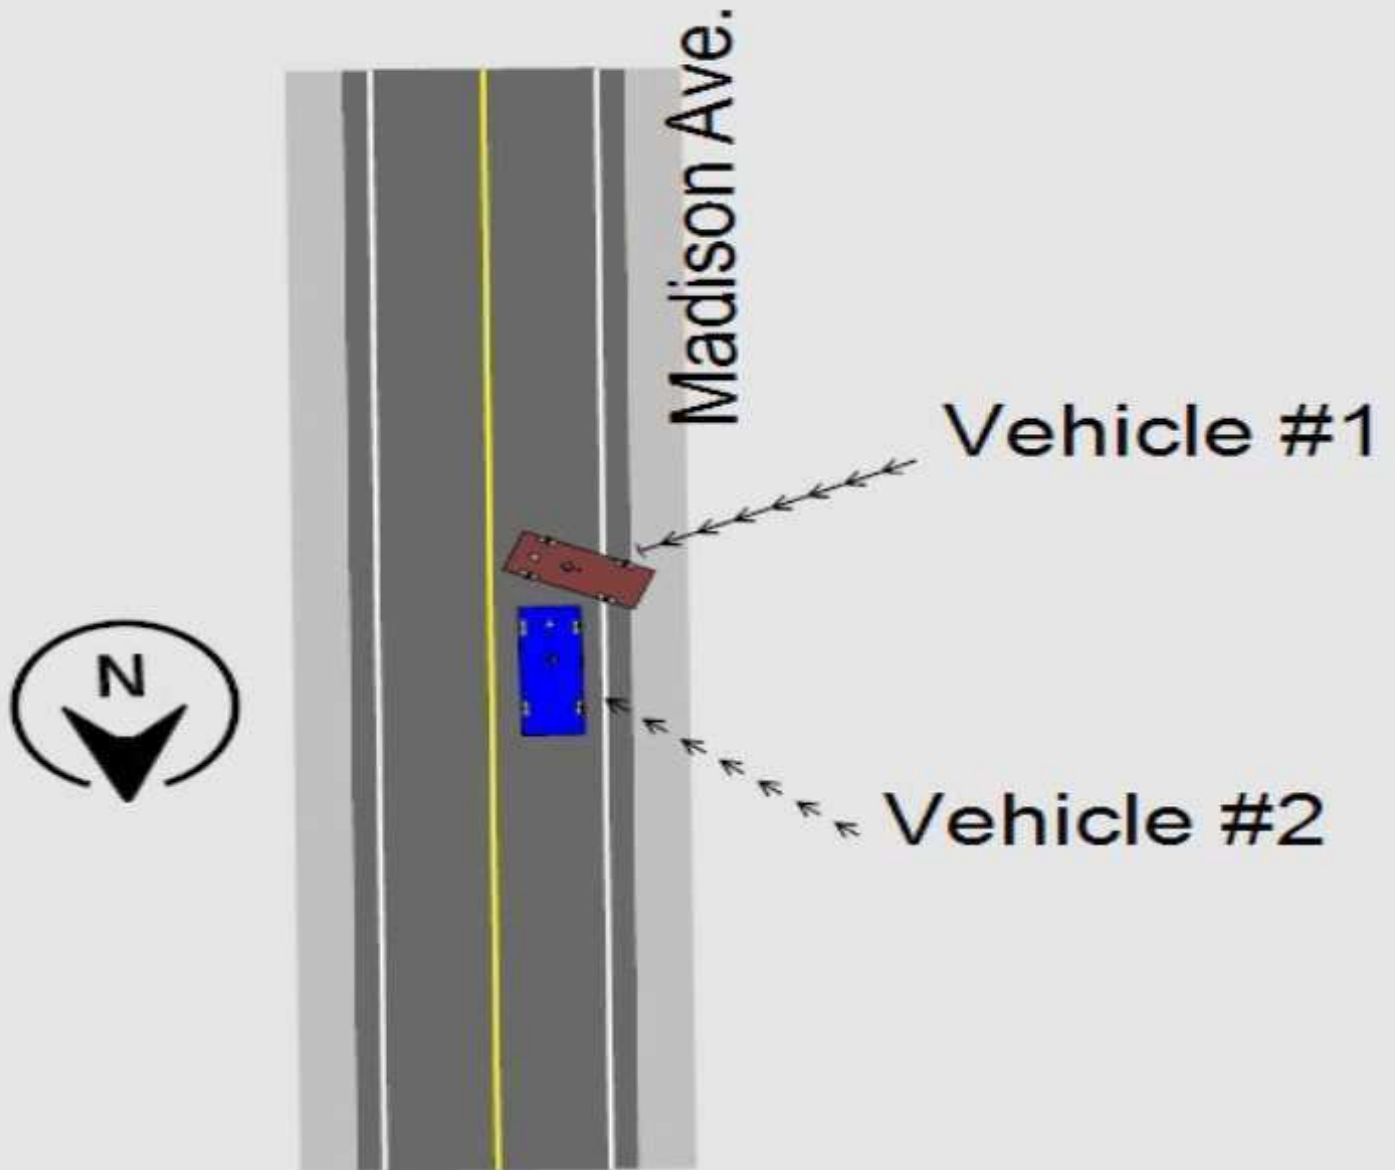
Both vehicles were traveling southbound on Madison Avenue when vehicle #1 -the lead vehicle - executed a sudden u-turn. The driver of #1, [REDACTED], told that he had not checked to his rear before executing the turn. Vehicle #2 struck the driver's door of #1. The damage to #2 appeared heaviest on the mid-right side of the van.
