## NARRATIVE

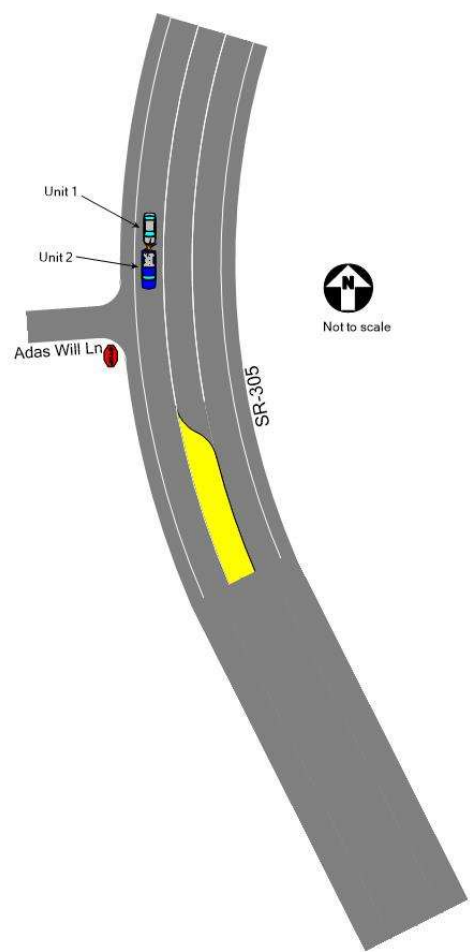
Unit 1 was travelling Southbound on State Highway 305 when Unit 2 started to slow down. There was heavy rain and the roads were very wet. Driver of Unit 1 admitted that they did not know they were travelling so closely, and hit the back end of Unit 2. Driver of Unit 1 said they were only travelling about 30-40 MPH.

Unit 1 sustained extensive front end damage.

Unit 2 sustained damage to the rear tailgate/ bumper area.
