## NARRATIVE

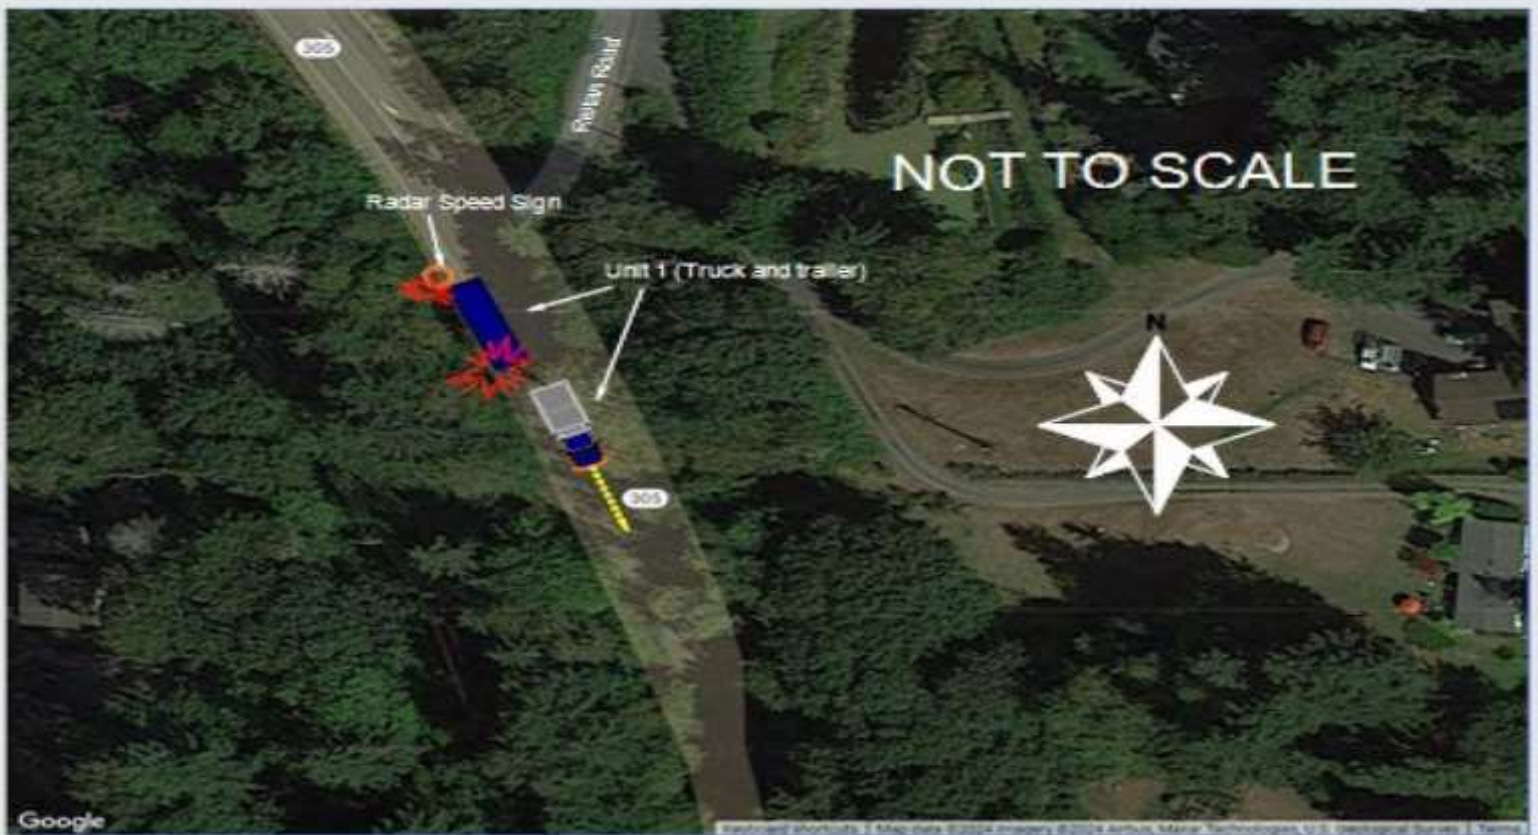
Unit 1, a [REDACTED] dump truck towing a rollaway trailer, was travelling southbound on State Route (SR) 305 just south of Reitan Road. Unit 1's driver looked in his left side mirror and observed that the trailer tongue was pointed toward the center of the roadway. The trailer was partially dragged in the southbound shoulder of SR 305 before it collided with a speed-limit radar sign just north of the construction site at SR 305 and Ada's Will, causing minor damage to the sign's taillights. The driver was able to safely stop and disconnect before manually moving the trailer's tongue safely out of the roadway.

Upon further inspection, it was discovered that the trailer tongue's connection to the trailer's chassis had partially failed due to corrosion.

[REDACTED] conducted an on-site weld repair of the trailer and safely removed the trailer from the roadway.
