NARRATIVE

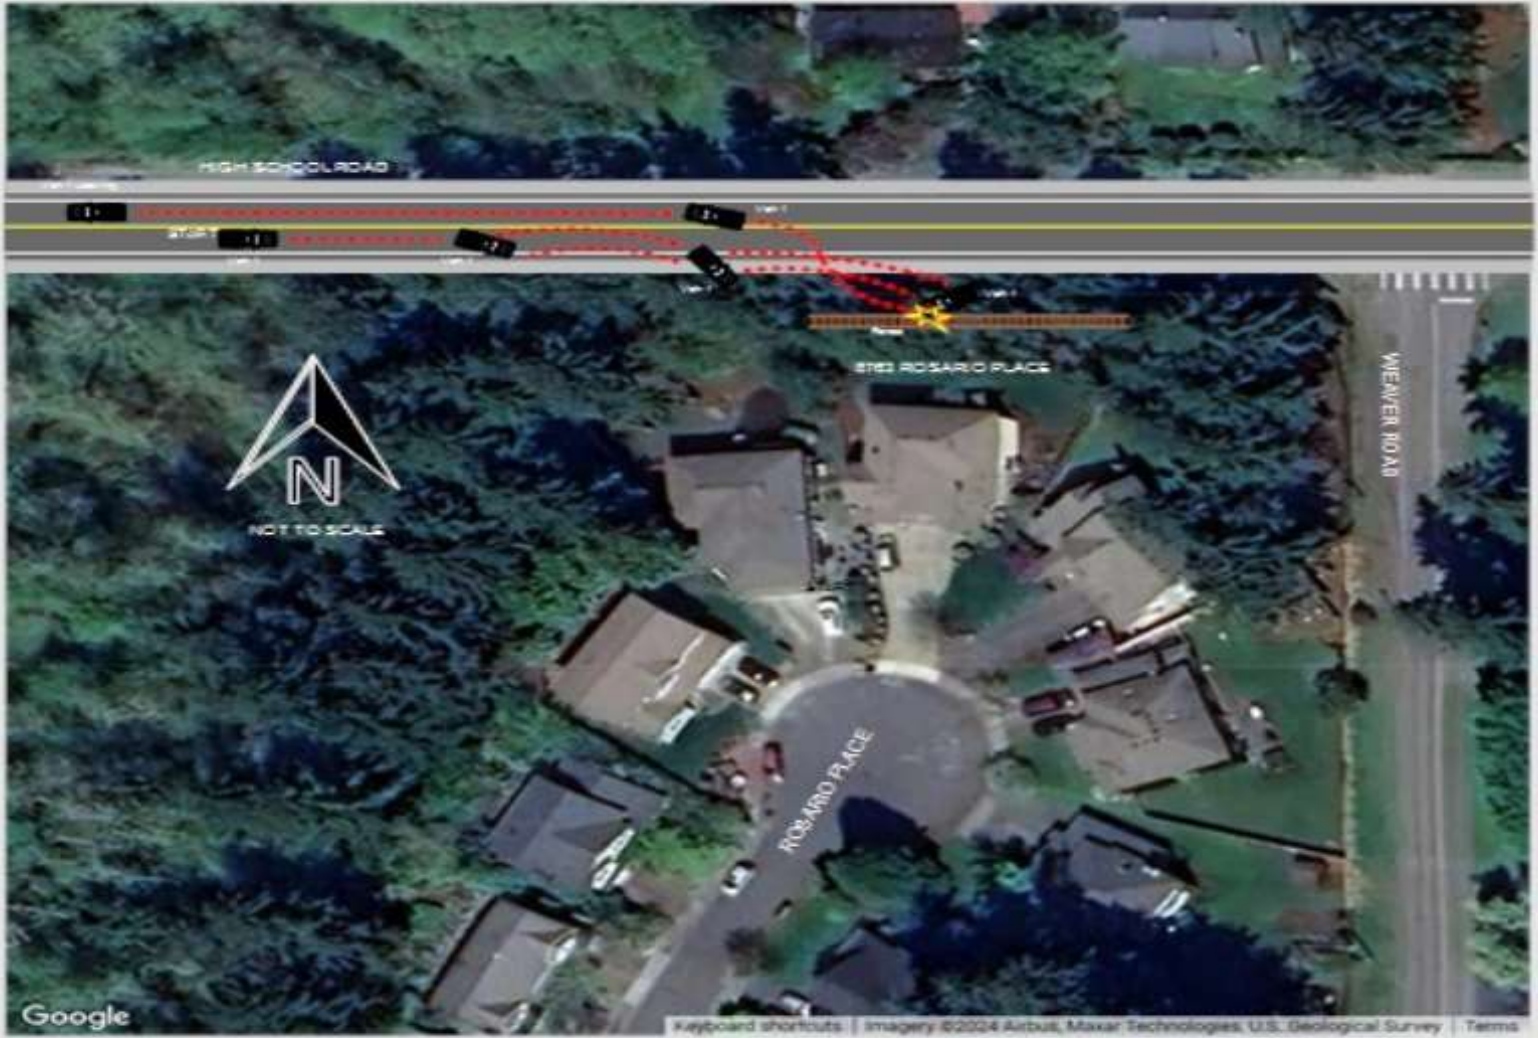
Vehicle 1 was traveling eastbound along High School Road. Rosario Pl was a culdesac just south of High School Road with back yards the abutted the south side of High School Road. The roadway was wet and Vehicle 1 was traveling uphill. As vehicle 1 approached where the back yard to 8763 Rosario Pl would abut High School Road, Vehicle 1 spun out on the wet roadway. Vehicle 1 spun up onto the curb, onto the grass along the south side of the road, and collided into the fence belonging to 8763 Rosario Place breaking a portion of the fence. Vehicle 1 then drove back westbound along High School Road and left the scene. The driver of Vehicle 1 called 911 approximately an hour later to report they were the responsible party.
