NARRATIVE

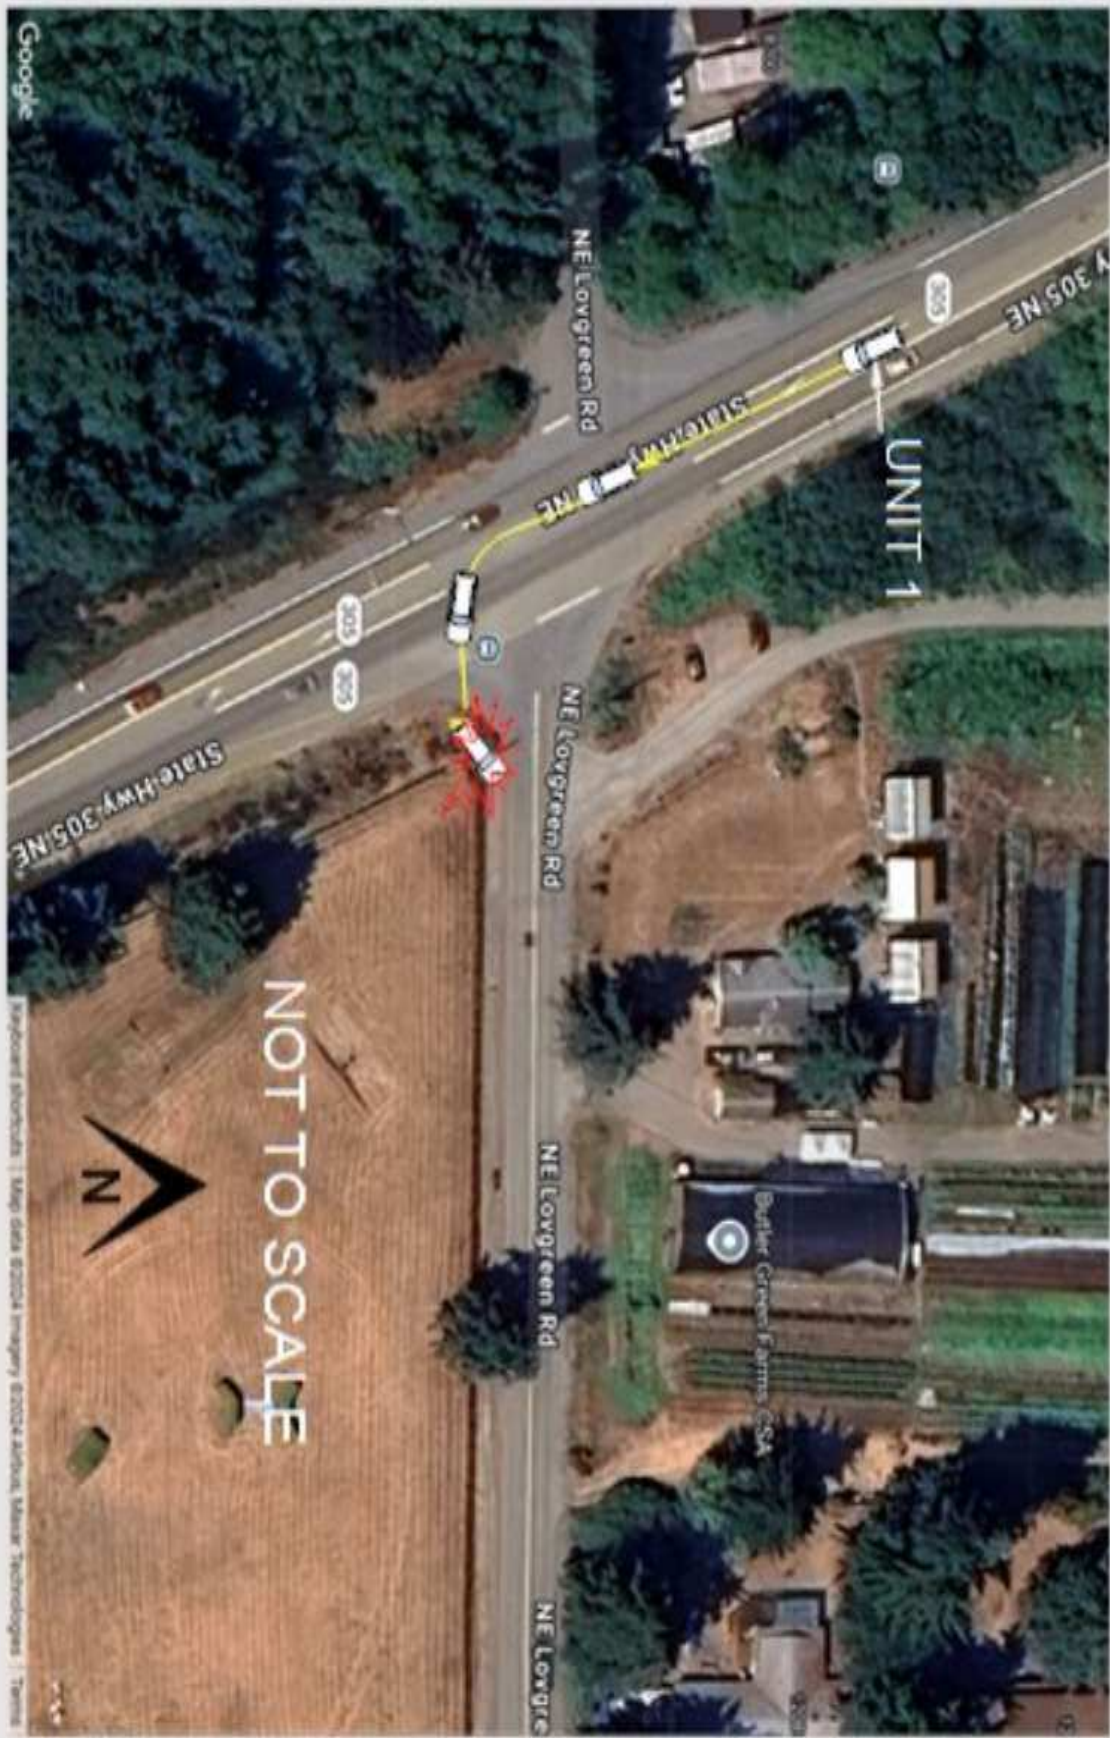
Unit 1 was travelling southbound on State Route 305 on Bainbridge Island preparing to make a left-hand (eastbound) turn onto NE Lovgreen Lane. As Unit 1 was turning, the vehicle hit a patch of gravel in the roadway, which caused the vehicle to temporarily lose traction and subsequently leave the road, travelling up and onto a berm on the southwest corner of NE Lovgreen Road and State Route 305.

Tire friction marks observed on scene indicated that speed was an apparent factor, although it is worth noting that a substantial amount of gravel was in the roadway. As a result, the driver was issued a notice of infraction for speeds too fast for conditions.
