## NARRATIVE

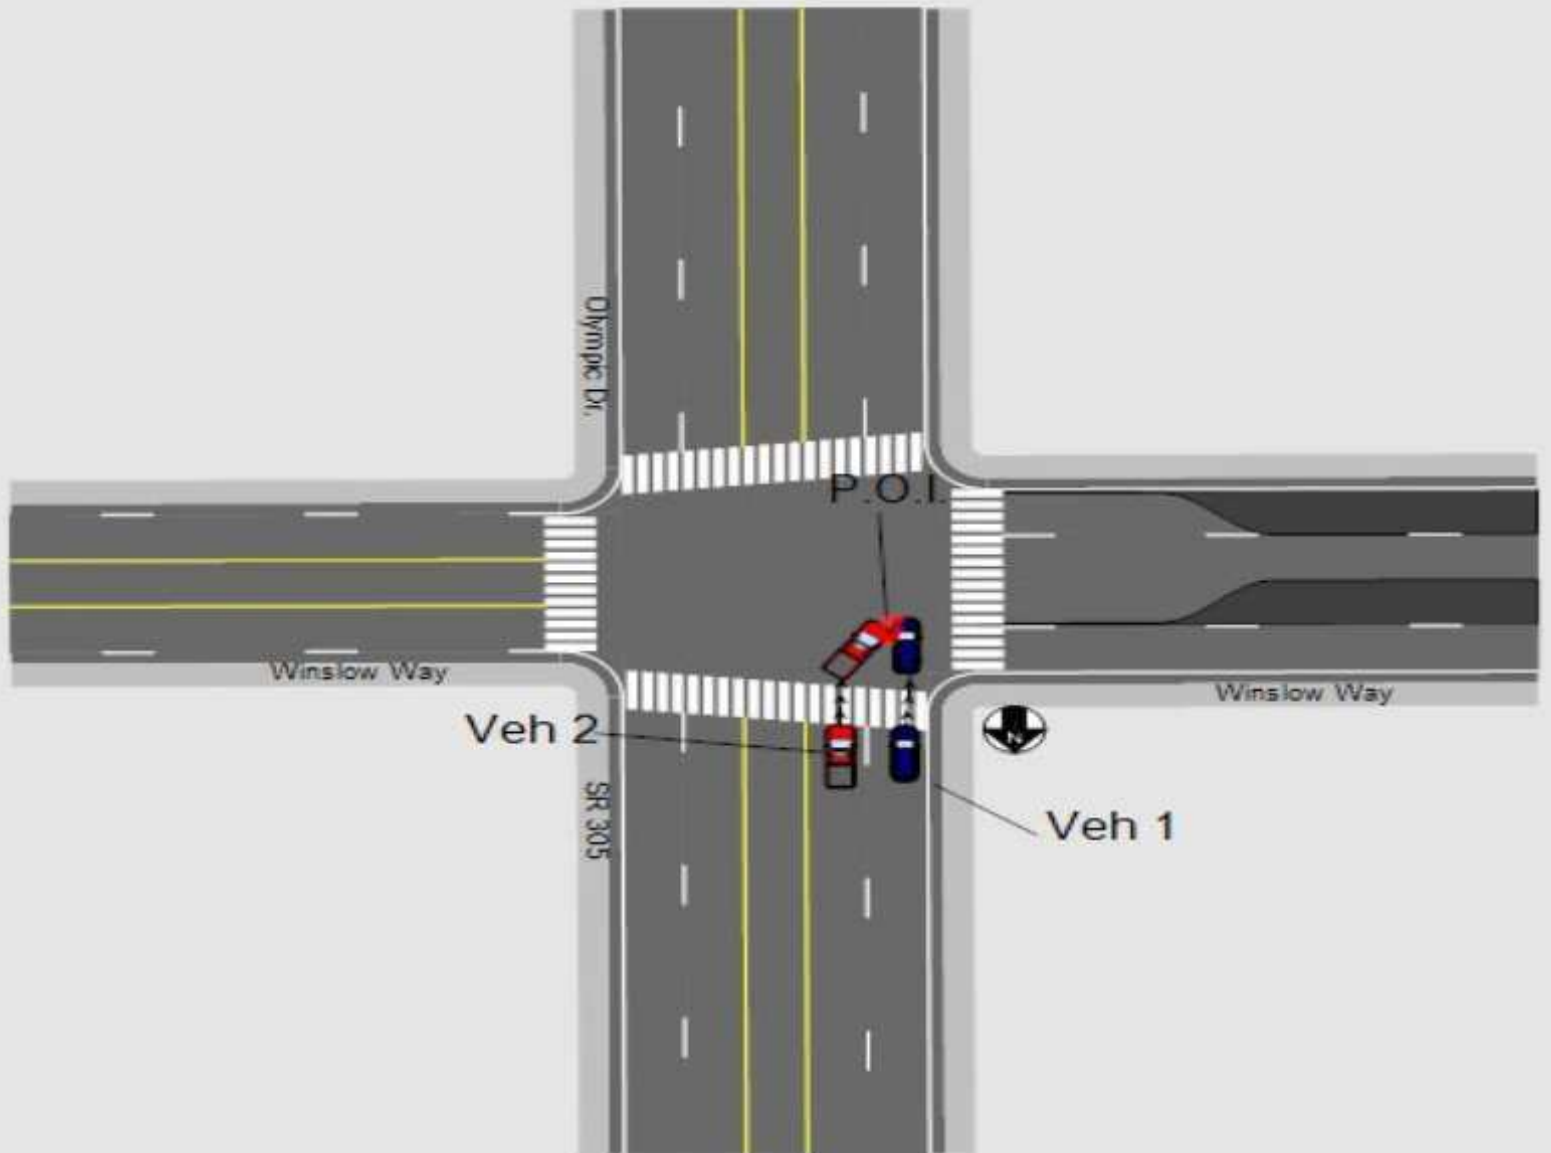
Vehicle 1 was in lane 1 of 2 on SB SR 305 in a ferry only lane that directs vehicles straight. Vehicle 2 was in lane 2 of 2 which is a lane for going left or right or straight for local traffic but is NOT a ferry line.

Vehicle 1's driver stated he got a yellow light and had to stop quickly and stopped in the marked area of no stopping. The subject then stated he thought he saw the light turn green and began to go forward and Veh 2 also had a green light to turn right and the vehicles collided in the intersection as vehicle 2 turned onto Winslow way.

The traffic lights at this intersection is new and the ferry line light is smaller than the other lights for Lane 2's traffic. the lights do not turn green at the same time. i believe the subject saw the other lights turn green and thought they were his due to the new light pattern which caused the collision.
