NARRATIVE

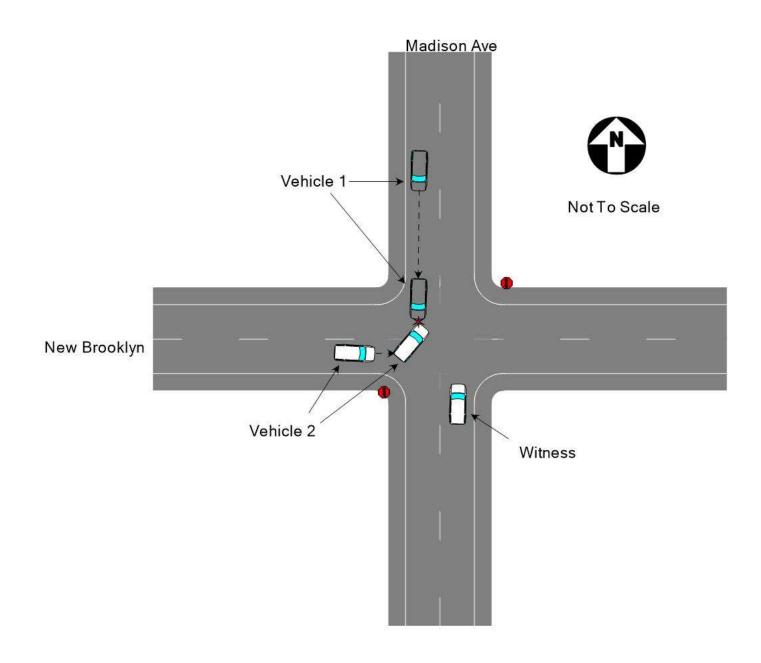
Vehicle 2 was intending to make the left turn to go north on Madison Ave.

Vehicle 2 entered the intersection, directly in front of Vehicle 1.

Vehicle 1 was traveling south on Madison Ave, approaching the intersection with New Brooklyn.

Vehicle 2 was east bound, stopped at the stop sign where New Brooklyn intersects with Madison Ave.

Vehicle 1 collided into the front left corner of vehicle 2.
