## NARRATIVE

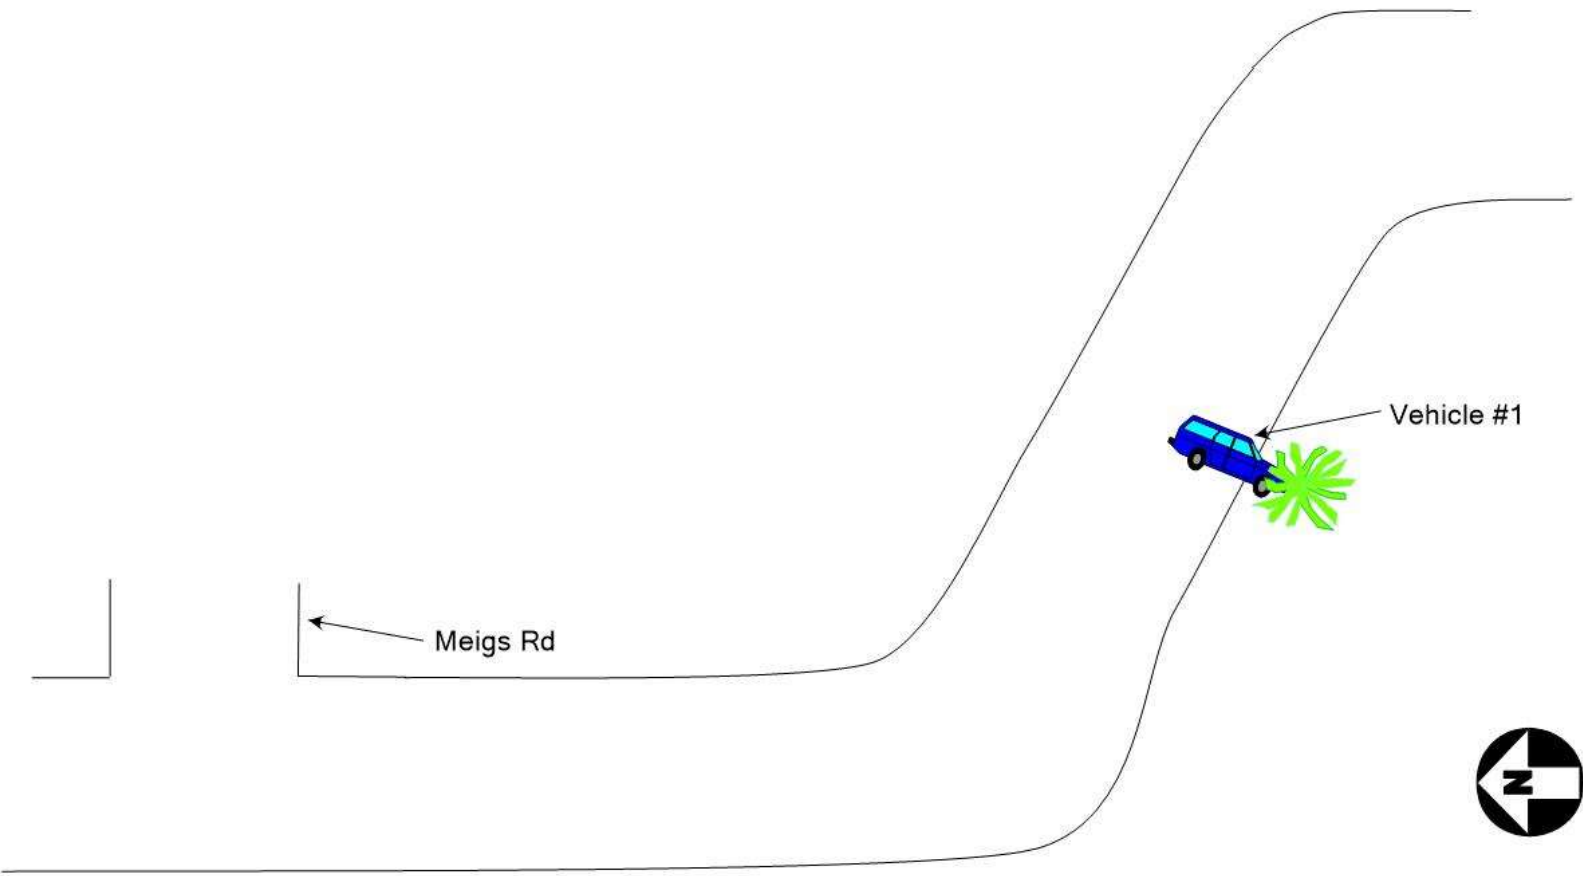
Vehicle #1 was moving south on Euclid when it entered the uphill “S-Turn” south of Meigs Rd. Upon entry into the turn the driver and both passengers reported that a deer was in the roadway. The driver maneuvered away from the deer but drifted onto the west grass covered shoulder. He went off the roadway in a yaw, leading with the driver’s side of the car. the shift in the center of gravity of the car caused the leading wheels begin to dig into the soft surface causing the car to roll to the left. All forward progress was stopped when the car struck a tree causing the car to rotate approximately 60 degrees.
