NARRATIVE

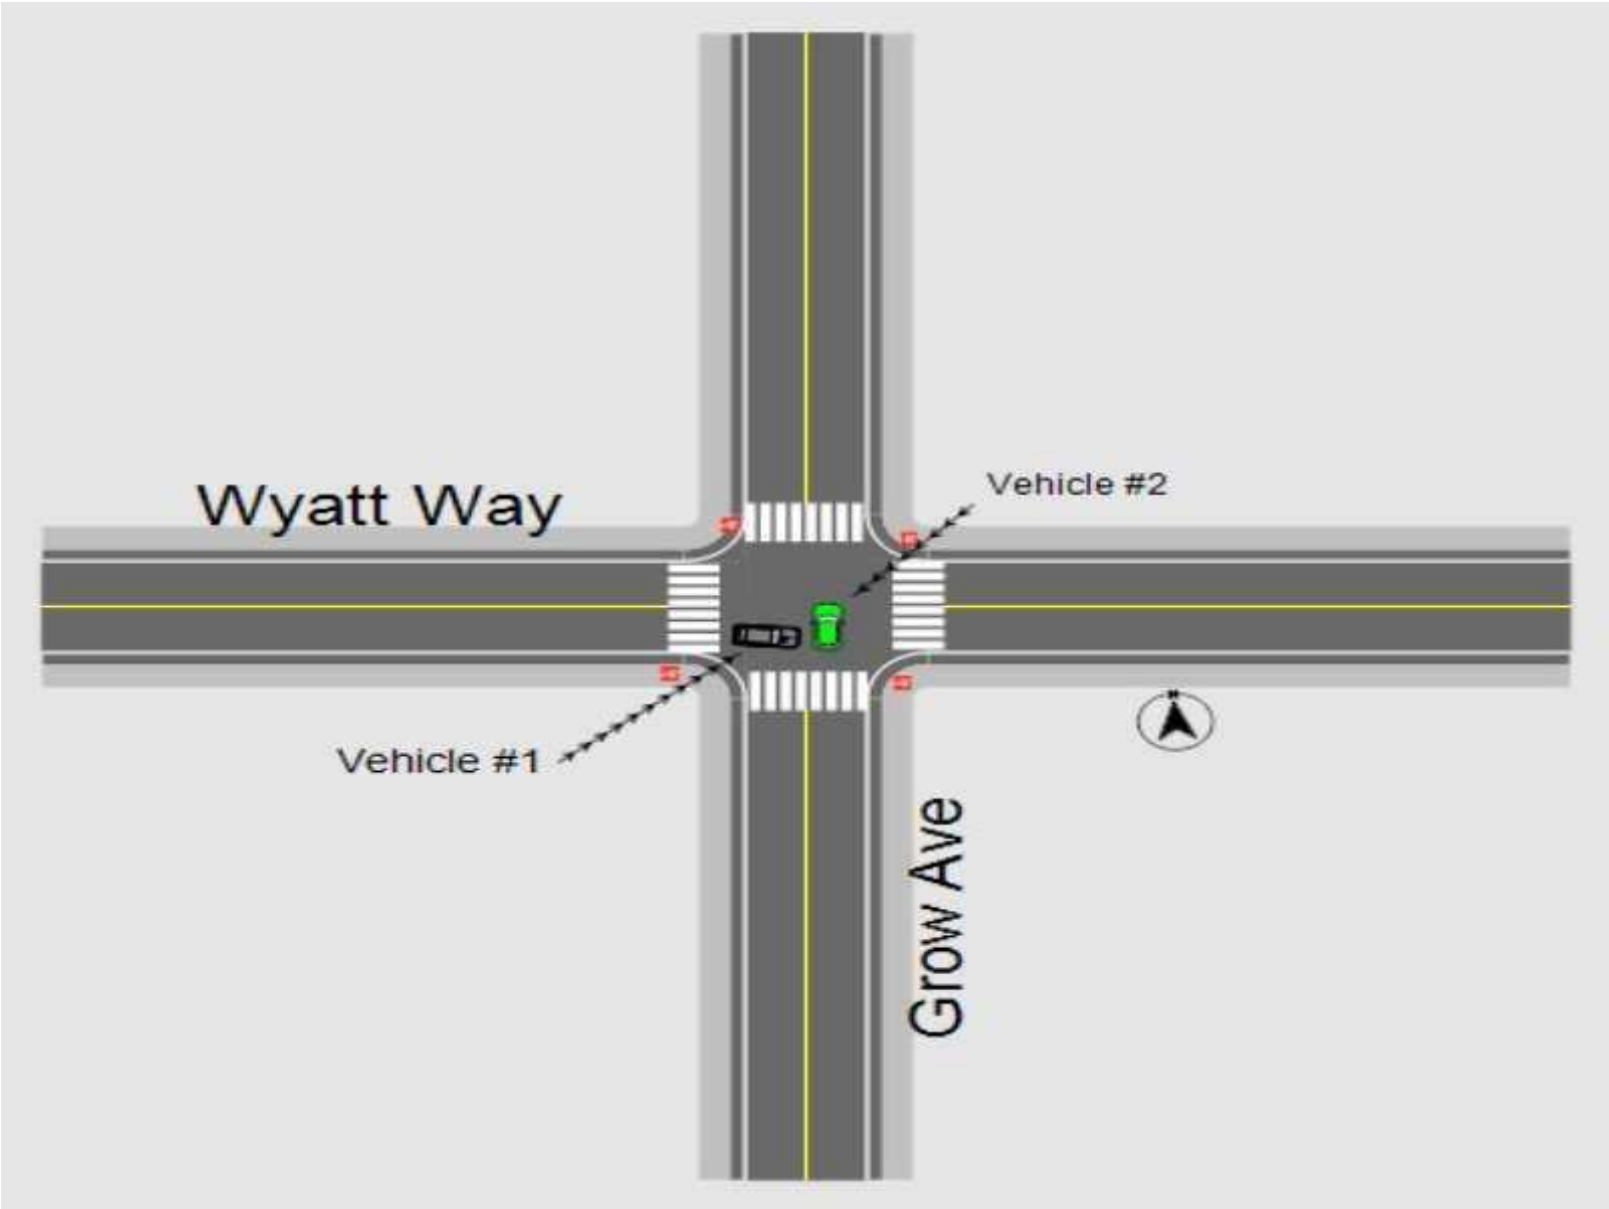
Vehicle #2 was in the intersection of Wyatt Way and Grow Ave. Vehicle #1 entered the intersection and collided with the driver's door of #2. The front driver's side light was the initial point of contact and the damage carried across the front of the car. Placement of damage and damage striations indicated that vehicle #2 was deep in the intersection at the moment of impact.
